**STATE OF HAWAII
DEPARTMENT OF LAND AND NATURAL RESOURCES
OFFICE OF CONSERVATION AND COASTAL LANDS
Honolulu, Hawaii**

REGARDING: Conservation District Enforcement File No. KA-06-78
Regarding Alleged Unauthorized Construction of Tension
Wire Fence Within the Conservation District Located at
Wainiha, Hanalei, Kauai,

Subject: Follow up Site Inspections for Haena-Wainiha, Kauai. Coastal Landscaping and Land Use Issues.

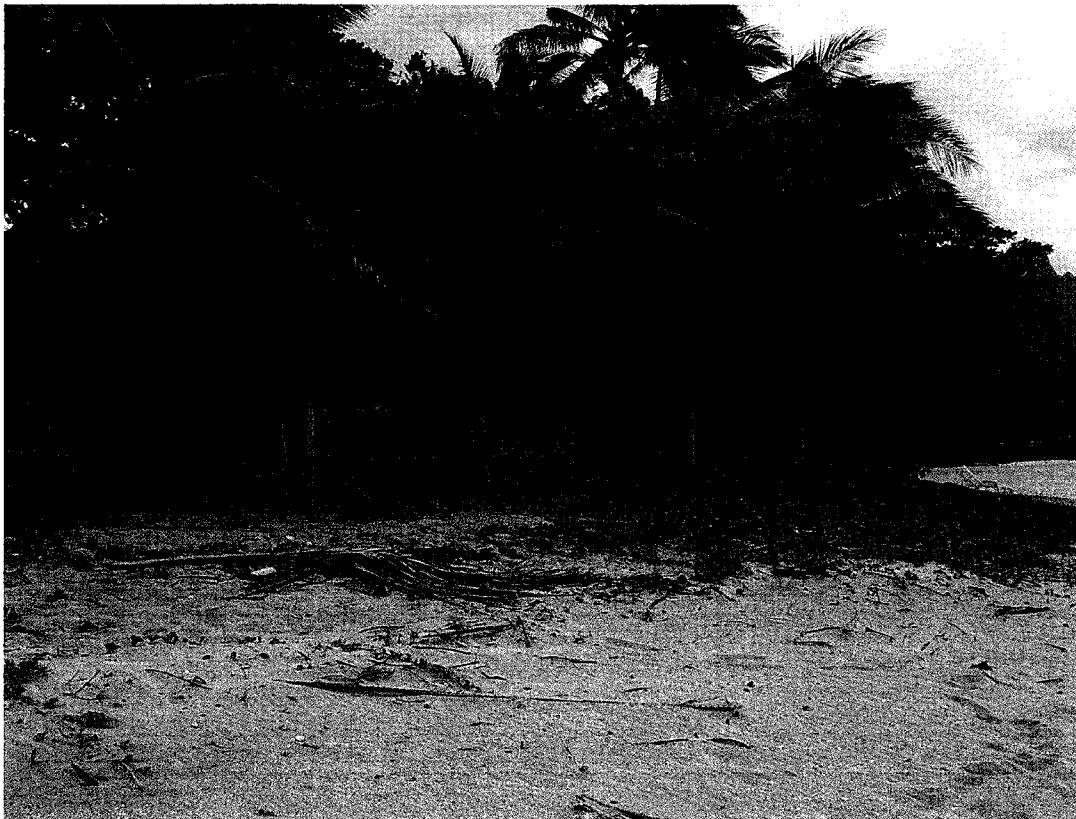
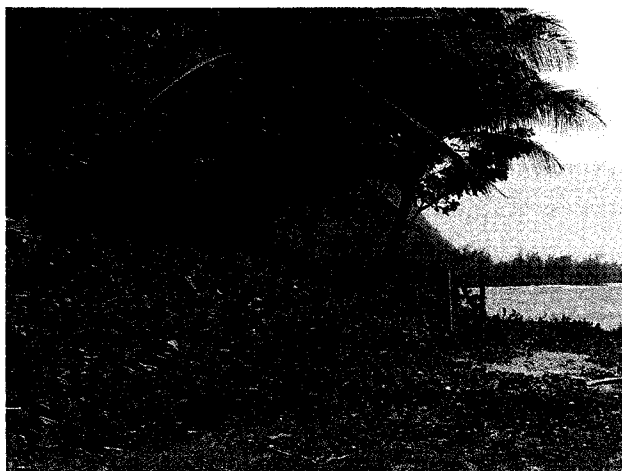
**Exhibit 2.
Subject Fence**

The subject property is located on the shores of Kanaha Beach, Haena, Hanalei District, island of Kauai, TMK:(4) 5-9-02:32 within the Limited Subzone of the Conservation District (Exhibit 1). The subject fence is composed of wood posts and tension wire and was constructed within the shoreline area (Exhibit 2). The subject area is adjacent to a wide white sandy beach. According to the Atlas of Natural Hazards in the Hawaiian Coastal Zone, the subject area is in a medium to high Overall Hazard Assessment area (Exhibit 3).

Staff recommends that the fence within the Conservation District be removed following the logic of the DLNR's "no tolerance" policy in regards to shoreline structures constructed after 1999. While the subject fence appears to be relatively minor in direct impact to shoreline processes it is representative of an evolving land use problem around the state involving landowner's efforts of restricting public access within the shoreline area that may be within the public trust. The case exemplifies a widespread land use problem in many shoreline areas that has led to the reduction of sandy beach access in areas like Haena and Wainiha on Kauai and Kahala and Kailua on Oahu. The Haena-Wainiha area appears to be particularly vulnerable to this problem and was the subject of a recent OCCL site visit (July, 23 2007) and status report related to allegations of unauthorized landscaping in the area (Exhibit 7). In many cases, once these landscaped areas are well established they not only narrow the usable sandy beach but in turn retard the run-up of the waves and thus the location of the shoreline.

4. The landowner shall remove the fence within thirty (30) days of the BLNR's decision;
5. Within 45 days of the decision, a Departmental Representative shall inspect the shoreline for compliance;

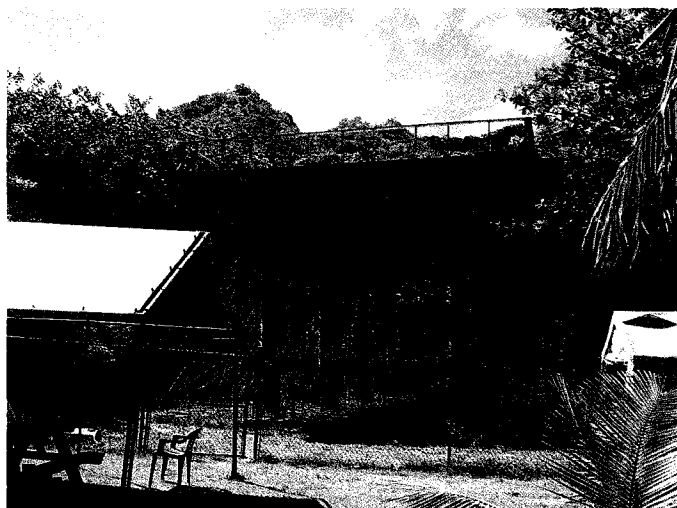
5-9-5:20 (Bendor) Construction Fence Chain link fence within setback. New dwelling subject of contested case for setback and height.

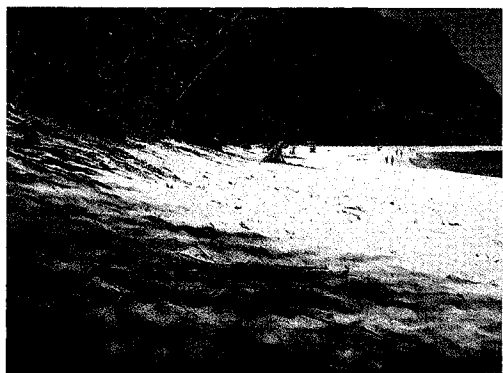
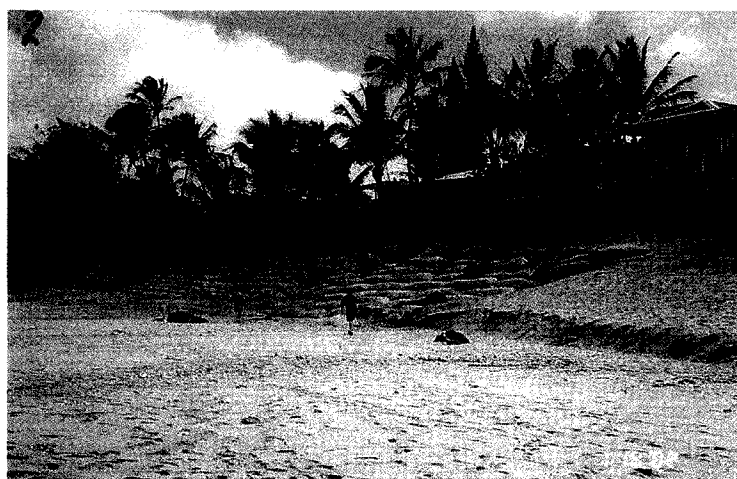
5-9-5:23-27 (Cooke) 1996 emergency SMA permit “emergency” sandbags Emergency passed, remove. No deadline and question the need for bags. Recommend removal of all the bags and development of long-term retreat strategy. This is a high-value recreational beach (one of the best in the state) that warrants proactive conservation and protection.

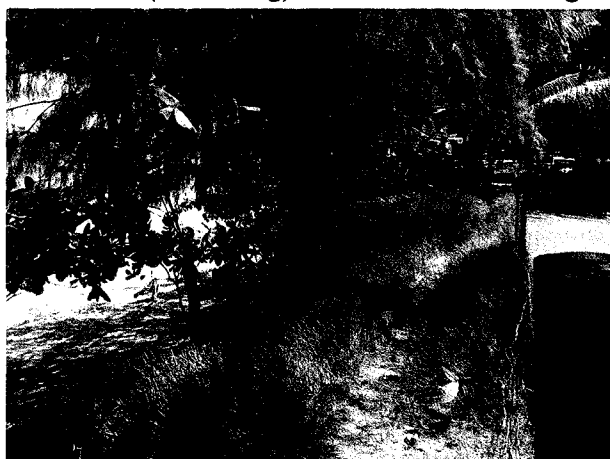
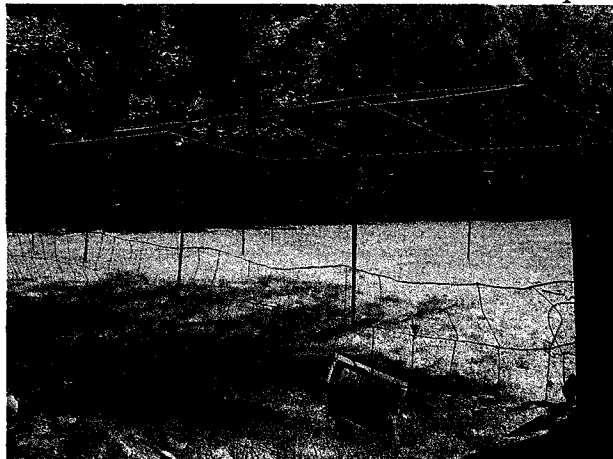
5-9-5:29 (Browning) Shoreline fence along shoreline Past violation closed? Fence still in place

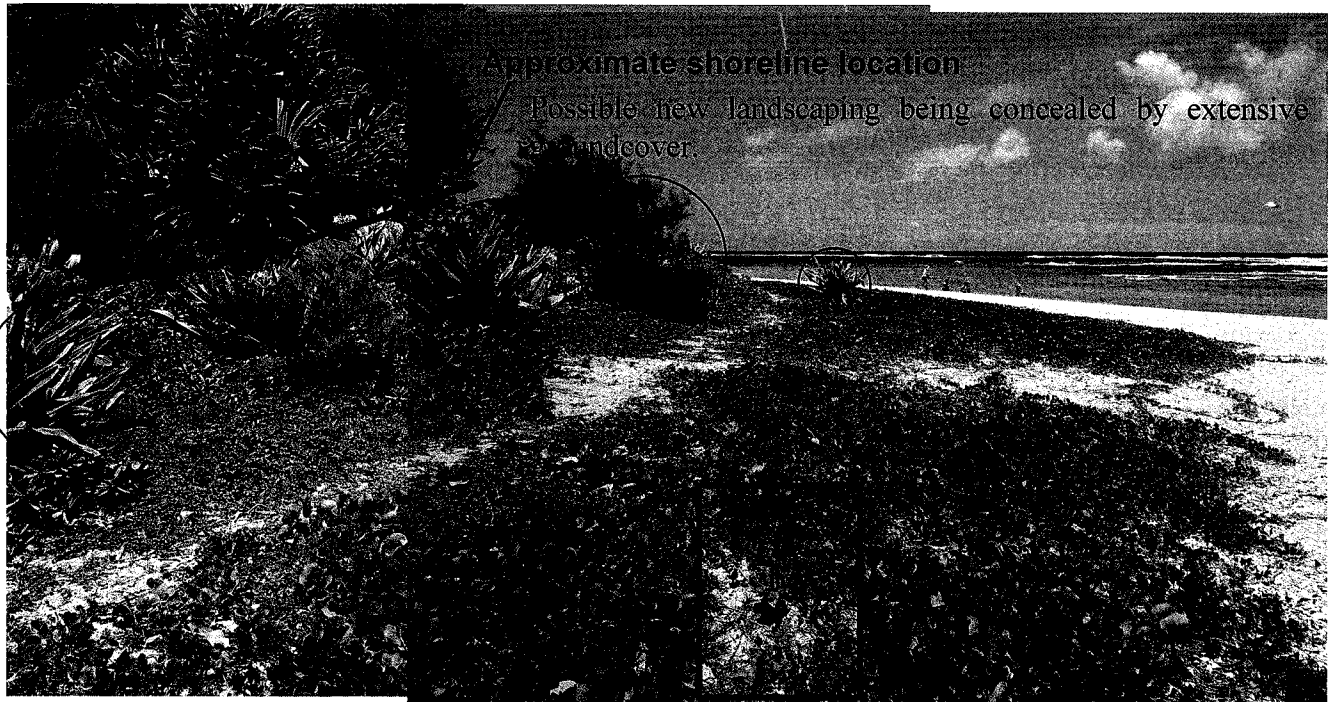
5-9-2:30 DAR/DOFAW habitat concerns (See Attachment 1) Shoreline landscaping? Not clear where property line is. Complaints of landscaping seaward of the shoreline. Vegetation appears to be encroaching seaward over time and large vegetated area covers beach seaward of shoreline. Complainant claims Ironwood trees (1-4 ft) appeared overnight and spiderlillies, Akiaki grass and morning glory are planted. Some vegetation shows signs of fertilizer burns and lack of horizontal root structure indicating it may have been planted rather than naturally rooted. Vegetation shows signs of maintenance with unusual vertical shoots and lack of offshoots. Appears the ground cover (naupaka and Morning glory) may be used to conceal other newly planted vegetation. Spoke to landscaper Mark Soppaland (808) 826-6183 regarding landscaping practices. Claims no landscaping conducted seaward of shoreline but only landward. Shoreline located approximately 30 feet landward of edge of vegetation. No obvious signs of sprinklers.

Recommendations: Initiate effort to clear vegetation seaward of the shoreline. Encourage landowners to not landscape seaward of the shoreline. Establish dune landscaping guidelines and conduct community workshops. Collaborate with Sierra Club (Weed the Beach program) to conduct a community clean up of this area.

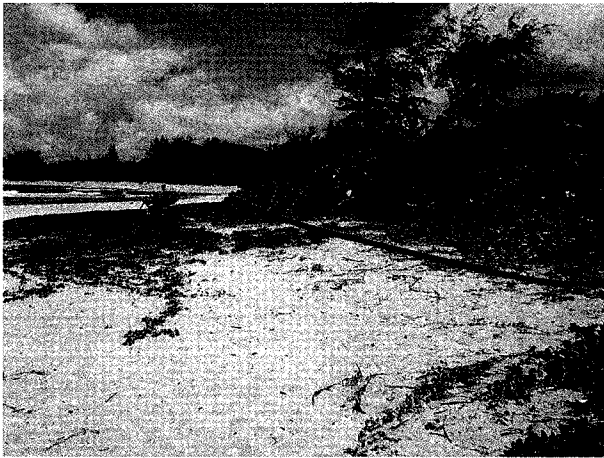
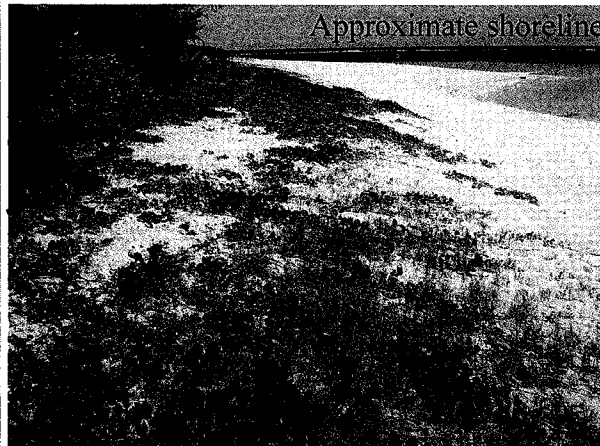
5-9-2:31 (Anawalt) Pending violation for unauthorized fence along shoreline (Violation # KA-06-77). DAR/DOFAW habitat concerns (See Attachment 1) Shoreline landscaping? Not clear where property line is. Complaints of landscaping seaward of the shoreline. Vegetation appears to be encroaching seaward over time and large vegetated area covers beach seaward of shoreline. Complainant claims Ironwood trees (1-4 ft) appeared overnight and spiderlillies, Akiaki grass and morning glory are planted. Some vegetation shows signs of fertilizer burns and lack of horizontal root structure indicating it may have been planted rather than naturally rooted. Vegetation shows signs of maintenance with unusual vertical shoots and lack of offshoots.

Recommendations: Immediate removal of unauthorized fence. Initiate effort to clear vegetation seaward of the shoreline. Encourage landowners to not landscape seaward of the shoreline. Establish dune landscaping guidelines and conduct community workshops. Collaborate with Sierra Club (Weed the Beach program) to conduct a community clean up of this area.

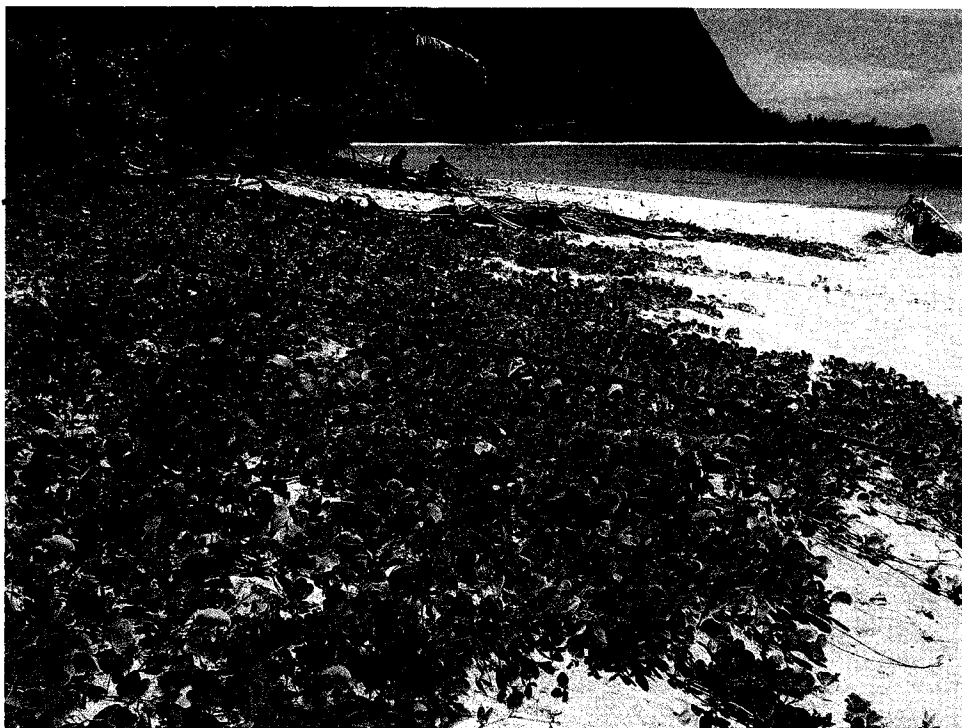
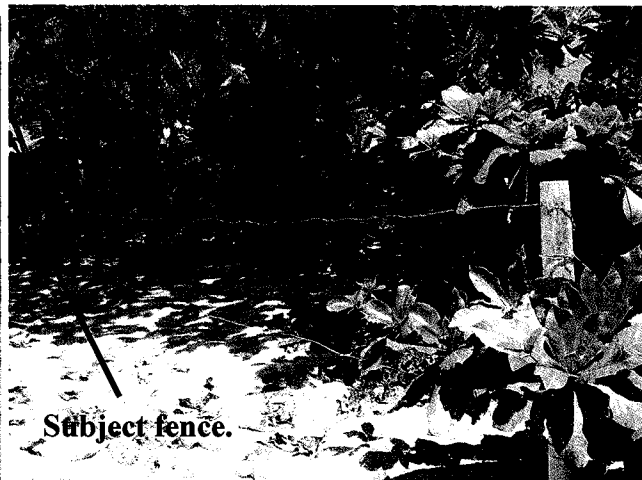
5-9-2:32 (Steelguist) Pending violation for unauthorized fence along shoreline (Violation # KA-06-78). DAR/DOFAW habitat concerns (See Attachment 1) Shoreline landscaping? Not clear where property line is. Complaints of landscaping seaward of the shoreline. Vegetation appears to be encroaching seaward over time and large vegetated area covers beach seaward of shoreline. Complainant claims Ironwood trees (1-4 ft) appeared overnight and spiderlillies, Akiaki grass and morning glory are planted. Some vegetation shows signs of fertilizer burns and lack of horizontal root structure indicating it may have been planted rather than naturally rooted. Vegetation shows signs of maintenance with unusual vertical shoots and lack of offshoots.

Recommendations: Immediate removal of unauthorized fence. Initiate effort to clear vegetation seaward of the shoreline. Encourage landowners to not landscape seaward of the shoreline. Establish dune landscaping guidelines and conduct community workshops. Collaborate with Sierra Club (Weed the Beach program) to conduct a community clean up of this area.

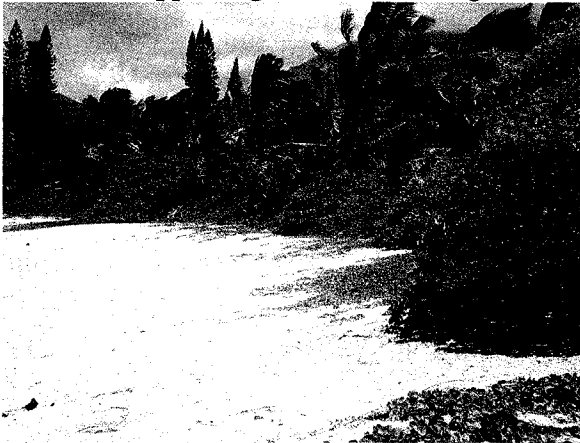
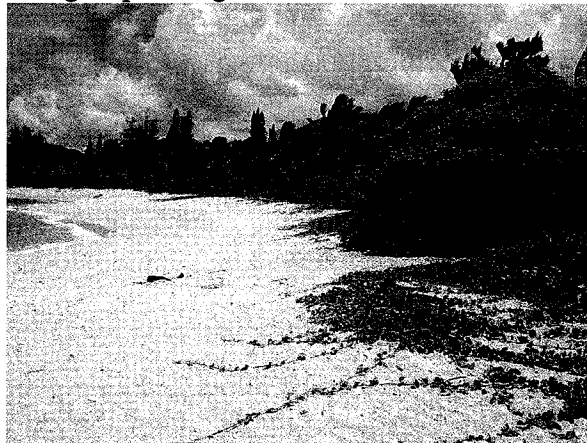
5-9-2:21 & 22 Not clear where property line is. Complaints of past landscaping seaward of the shoreline. Vegetation appears to be encroaching seaward over time and large vegetated area covers beach seaward of shoreline. Old irrigation now removed but vegetation may have been established to be self supporting. No obvious signs of watering or planting at this time.

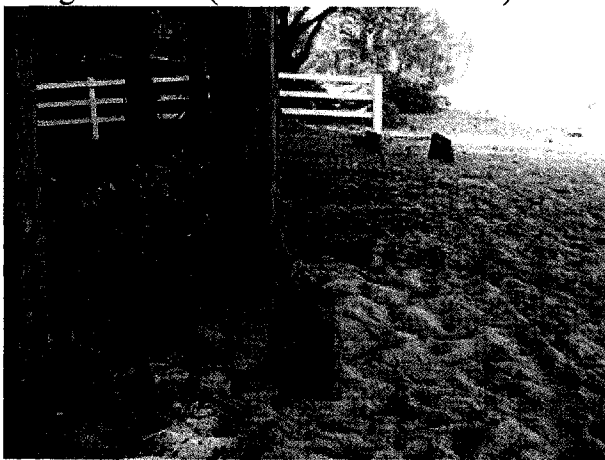
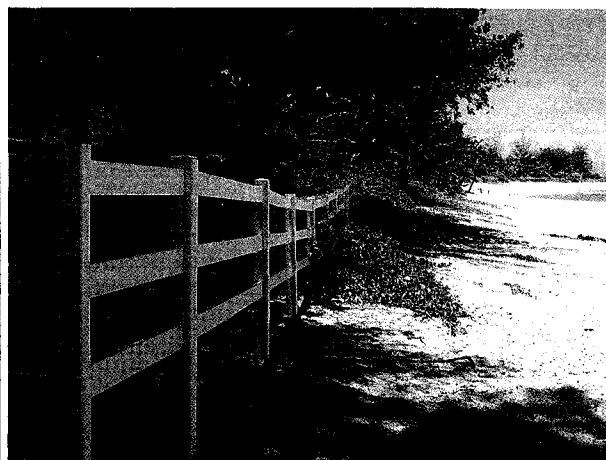
5-8-10:17 (YMCA) Not clear where property line is. Pending violation for unauthorized fence along shoreline (Violation # KA-06-81).

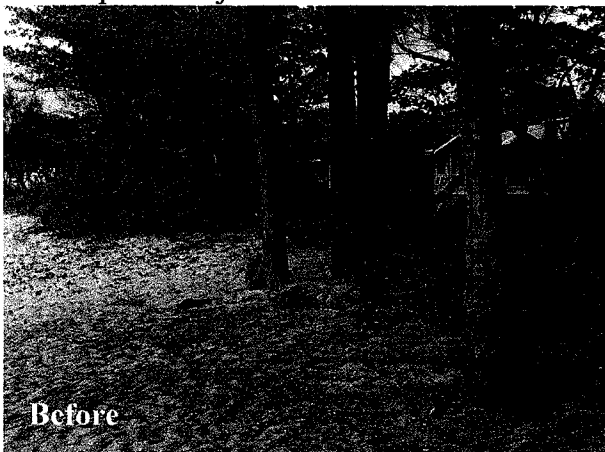
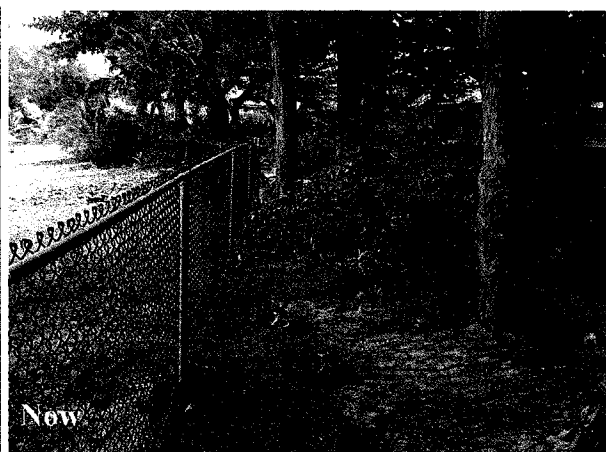
5-8-09:57 (Smith) Pending violation for unauthorized fence along shoreline (Violation # KA-06-72- contested case). Vegetation appears to be growing seaward not clear if it is natural or landscaped. Subject material all seaward of shoreline.

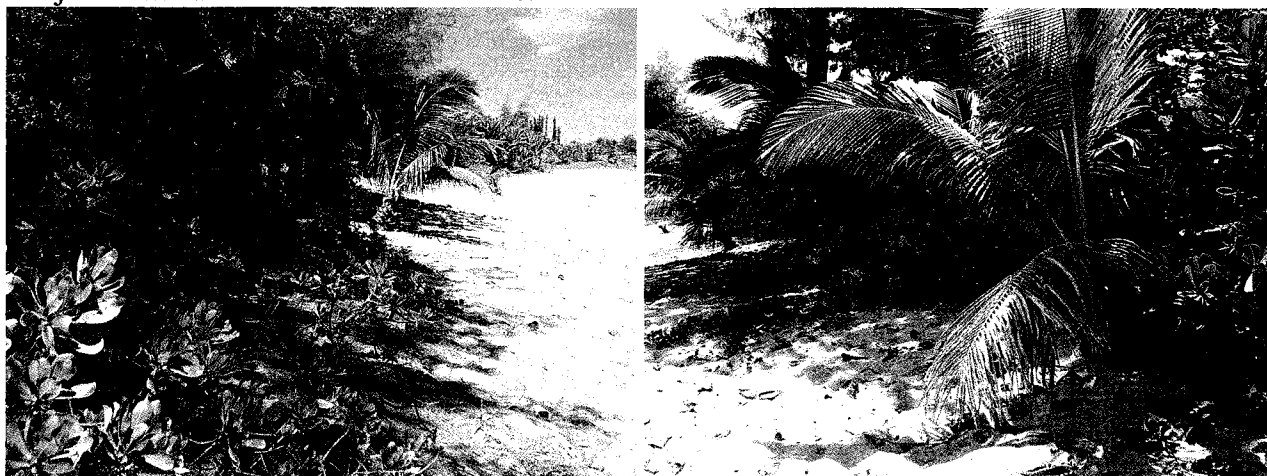
5-8-09:58 & 25 Vegetation appears to be growing seaward not clear if it is natural or landscaped. Subject material all seaward of shoreline.

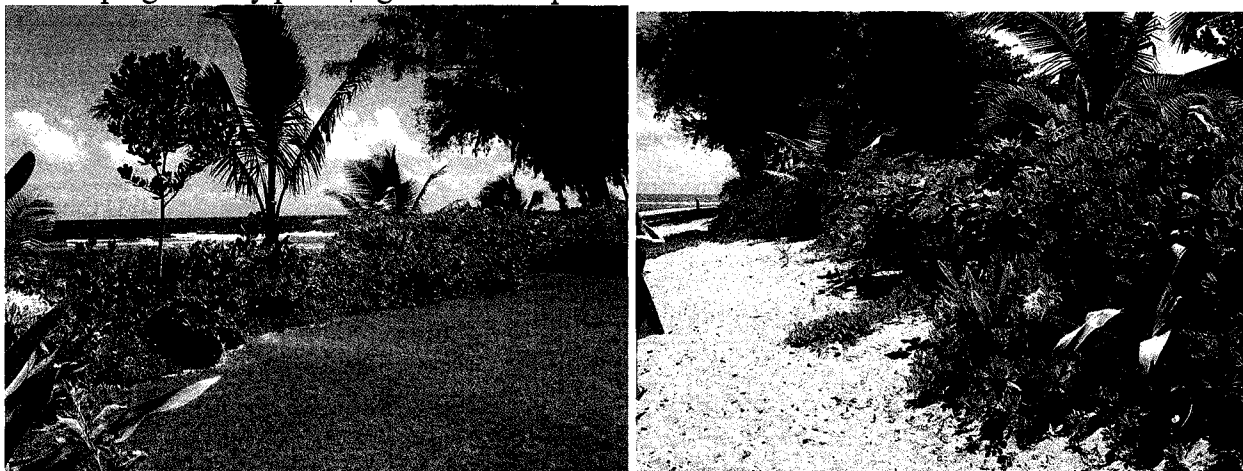
5-8-09:41 (Lot 2) Previous supreme court case regarding shoreline certification based on planted vegetation. Vegetation appears to be growing seaward, efforts to remove vegetation ineffective. Subject material all seaward of shoreline. Older photos show dramatic change in vegetation due to landscaping. Newly planted grass and naupaka within setback area.

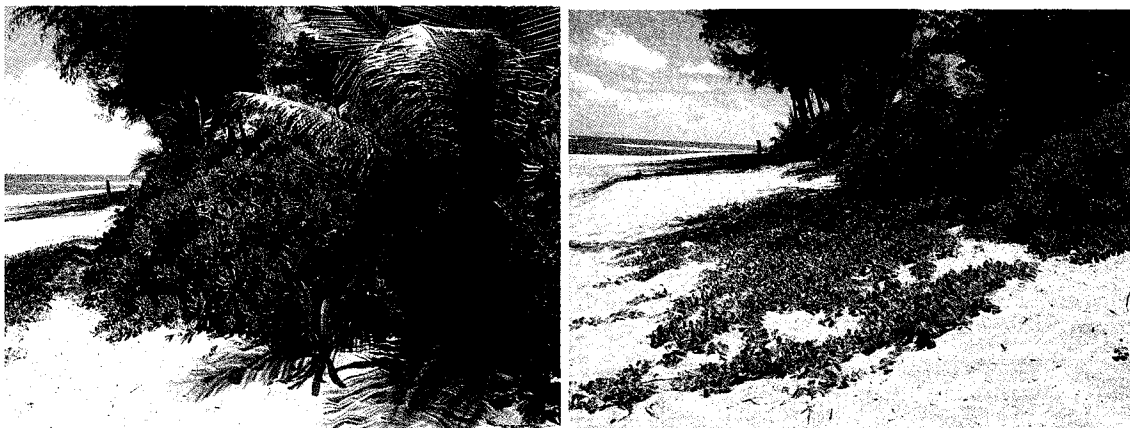
5-8-09:42 (Lot 3) Vegetation appears to be growing seaward. Subject material all seaward of shoreline. Older photos show dramatic change in vegetation due to landscaping. Most seaward vegetation in area.

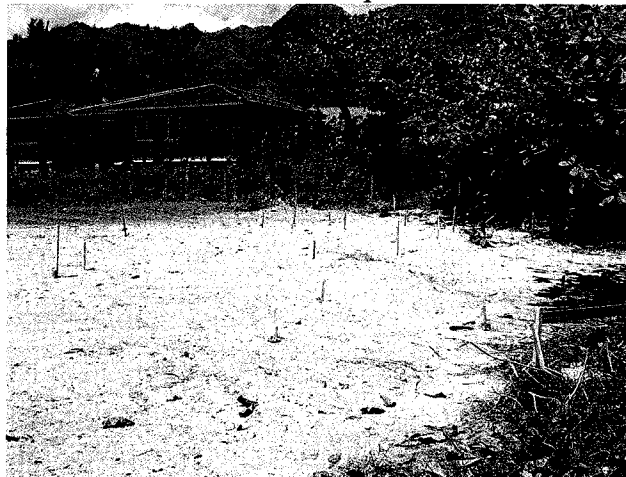
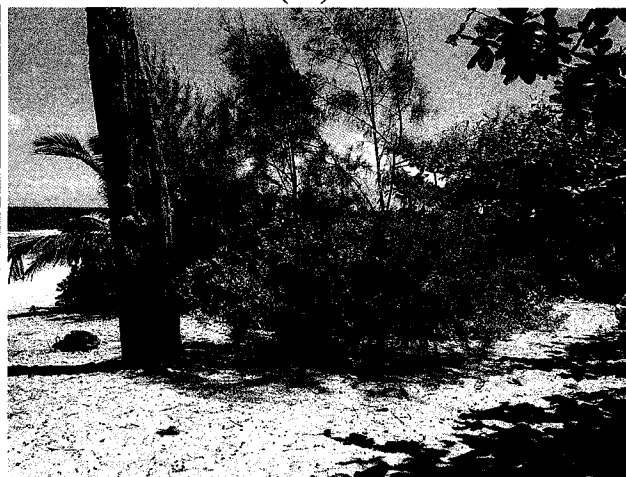
5-8-09:45 (Lot 6) Vegetation appears to have grown seaward in the past but is stable more recently. Older photos show dramatic change in vegetation due to landscaping. Contested shoreline and setback. Multiple burials discovered within setback area (28).

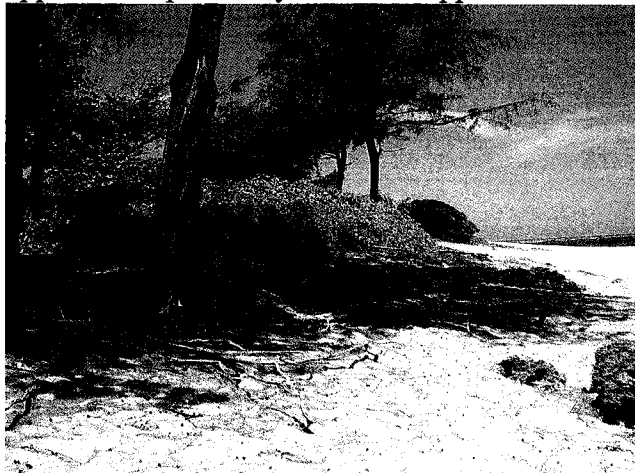
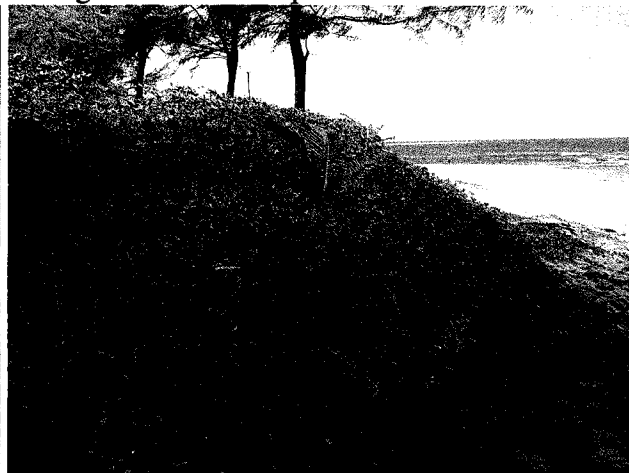
5-8-09:47 (Lot 8) Vegetation appears to have grown seaward in the past but is stable more recently. Older photos show dramatic change in vegetation due to landscaping. Shoreline under appeal. Naupaka very thick and appears to be inhibiting the wave run-up.

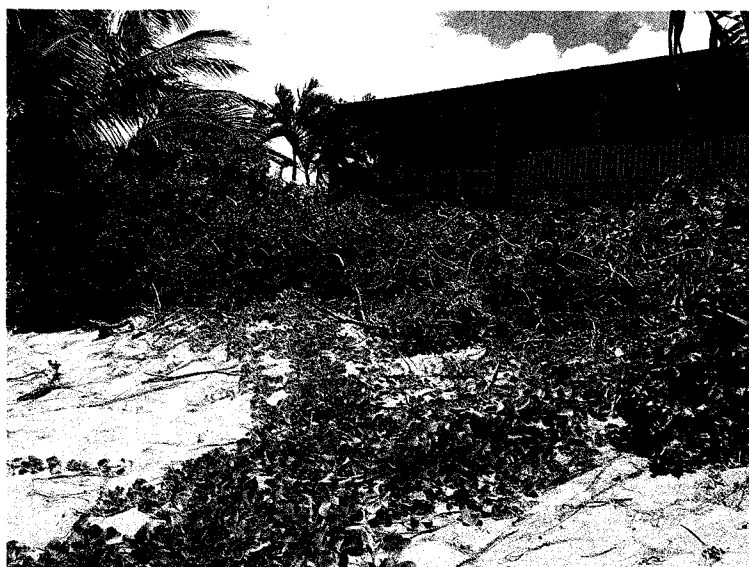
5-8-09:48 (Lot 9) Vegetation appears to have grown seaward in the past but is stable more recently. Older photos show dramatic change in vegetation due to landscaping. House on lot, owner accuses Mrs. Diamond of recent vegetation removal.

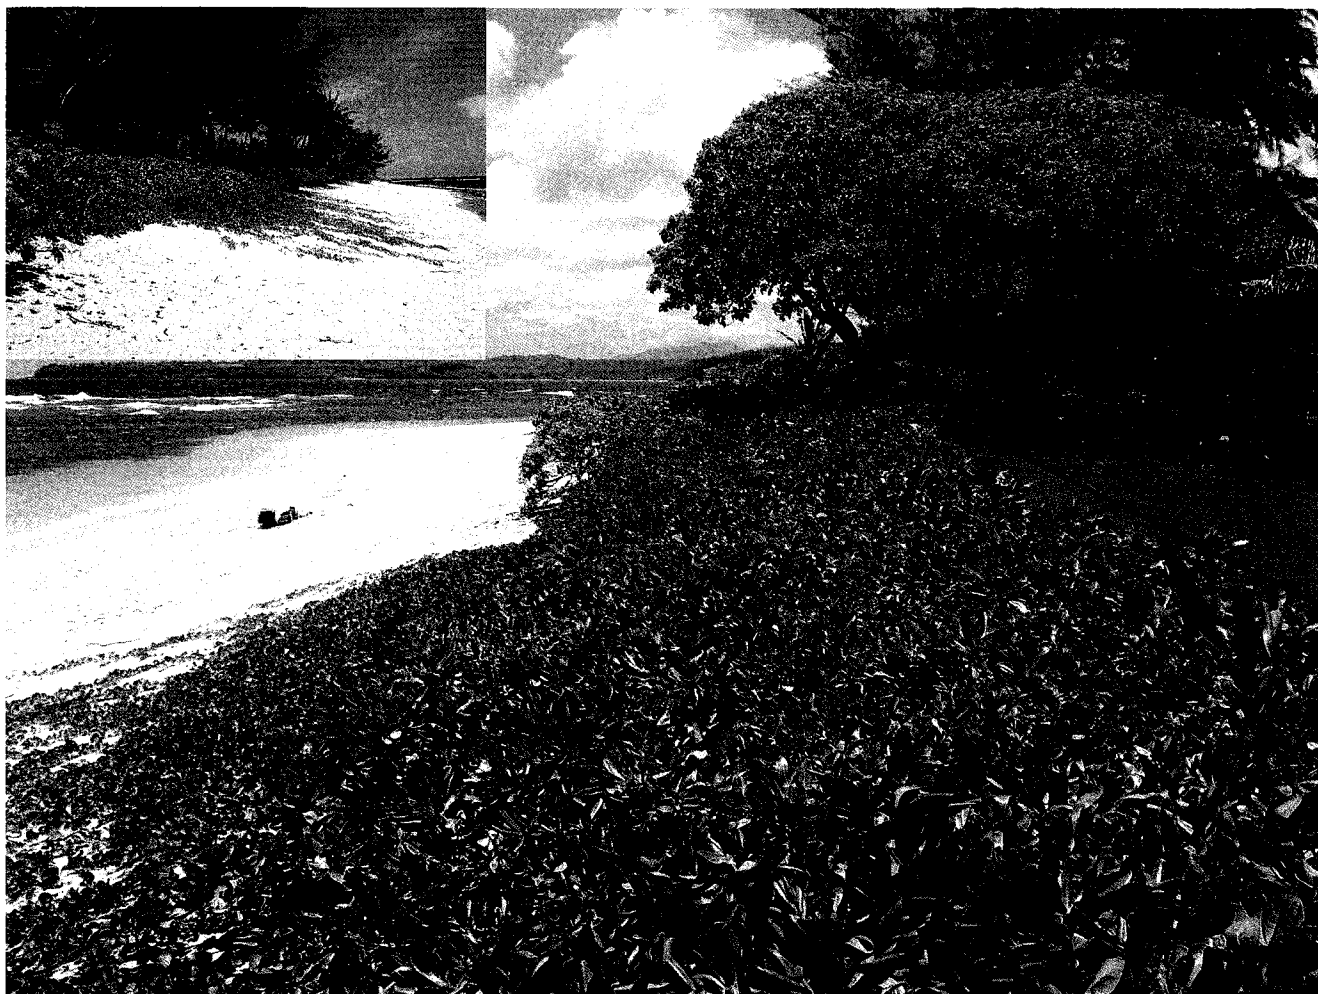
5-8-08:38 (Michaels) Vegetation appears to have grown seaward more recently. Past complaints of landscaping seaward of the shoreline and burying rocks to create a wall within the dune. Vegetation excursion down beach face. Complaints of planted vegetation (naupaka and Heliotrope) seaward of 2003 shoreline. 2003 shoreline shown in red (no vegetation present at that time).

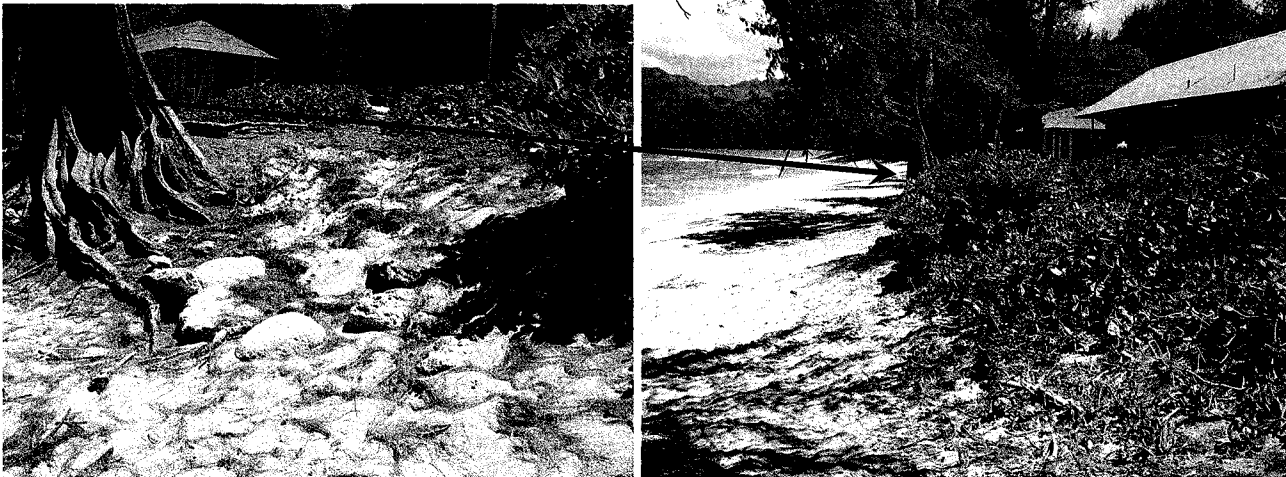
5-8-12:07 (Michaels) Vegetation appears to have grown seaward more recently. Past complaints of landscaping seaward of the shoreline and burying rocks to create a wall within the dune (see 5-8-8:38). Vegetation excursion down bank. Complaints of rocks placed seaward of 2003 shoreline. Observed 11 rocks next to ironwood tree. Will monitor for change. Shoreline may be landward of dwelling.
